# Manhole Inspection Summary

Manhole # S21AA\_033MH

**Location** Address: **823 FULTON-MOUNT**

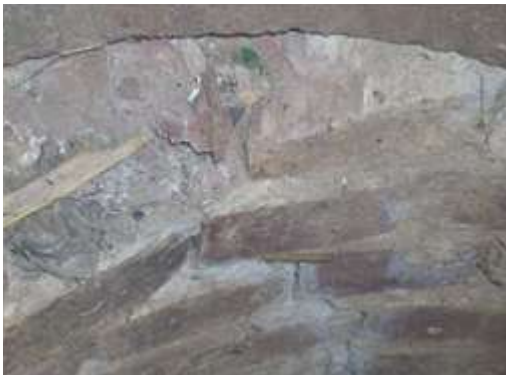
Defect 3

Condition: ☐ Sound ☒ **Cracked** ☐ Root Intrusion ☐ Loose Brick ☒ **Deteriorated**

CORBEL DETERIORATION

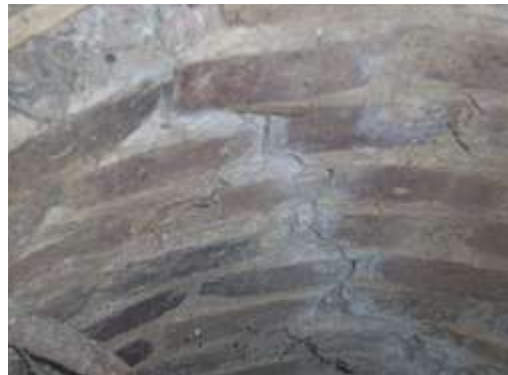
Defect 2

Comments **REWORK WAS "NEED PHOTO OF CRACKED BARREL" - REINSPECTED BARREL  
USING MAN ENTRY - NO DEFECTS TO BARREL, OBSERVED CRACKED CORBEL  
ONLY. INSPECTION RECORD UPDATED IN MIAS - REWORK COMPLETE.**

CRACKED CORBEL

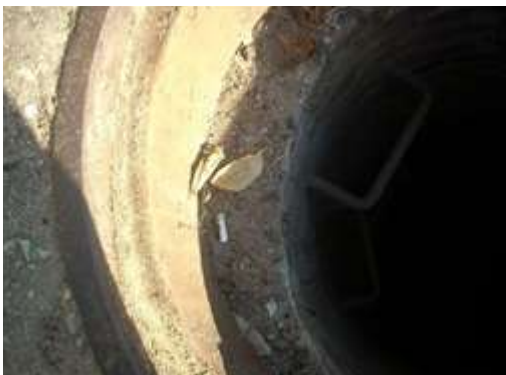
Defect 1

**Frame** Offset: **4** (in.) Condition: ☒ Sound ☐ Cracked ☐ Leaks

FRAME OFFSET

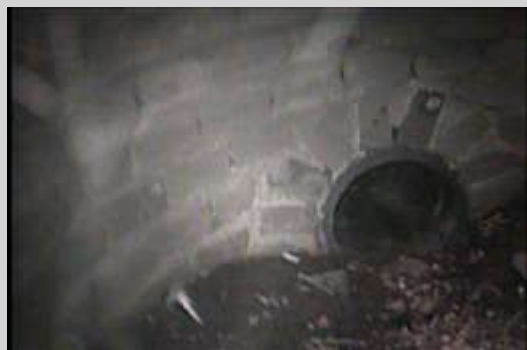
12 O'Clock Outflow

8 in. Circular Gravity Sewer  
Pipe Out @ 12 O'Clock

Deposits: ☐ None ☐ Mud ☐ Sludge ☒ **Debris** ☐ Grease

Silt Depth: **2** (in.) Deposits Extent: **Light**
